## FALL RIVER HISTORICAL SOCIETY

ISSUE 06 | SUMMER 2025

## SPECIAL INFRASTRUCTURE ISSUE

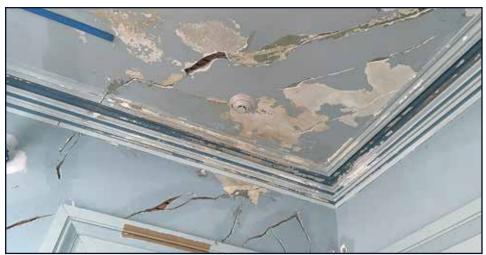
Walls and ceiling in SW storage room, 3rd floor, after damaged plaster was removed by FRHS volunteers and staff.

- ▼ To ensure plastering and painting contractors the ability to move from room-to-room on the third floor to commence work in a timely fashion, messy "grunt work" was undertaken by FRHS volunteers and staff. Several weeks have been spent dealing with major plaster problems from removing loose plaster, opening cracks, and scraping delamination and scraping peeling paint. The work is dirty, dusty, and very labor intensive. For going to the extreme, the FRHS gratefully acknowledges **Trish Rebello**, **Kathy Rockett**, and **Betty Prescott**.

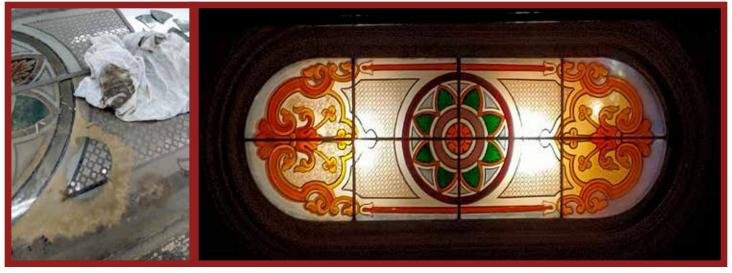
Left: The initial stage of cleaning. The heavy layer of accumulated grime is evident. Right: The skylight installed following restoration.

In the 155 years since its installation, the glass became further darkened by layers of grime and all manner of detritus that had accumulated on its surface, including dust, insulation, small debris, and scattered animal and insect deposits. There was also considerable damage and losses to one of the semicircular end panels.

The work on the window was undertaken by stained glass conservator James Donahue Jr. of New England Stained Glass, whose initial visit to the Fall River Historical Society was to conduct a physical

"This window had multiple colors of glass stains (deep yellows/oranges) as well as black, brown, and blue paints, and went through a total of ten firings for each piece to achieve the right color matches.
